# TECHNICAL BULLETIN

**MODEL/DERIVATIVE:**  
Discovery series II (LT)

**Bulletin N°:** 0108  
**CDS. ref:** L8828bu  
**Issue:** 1  
**Date:** 23.10.02

**WATER INGRESS INTO REAR OF VEHICLE**

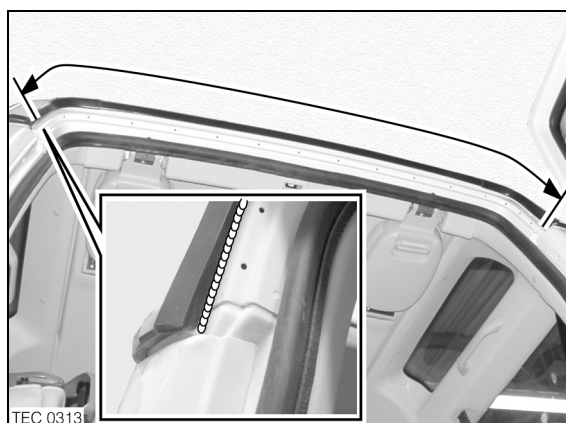
1

Sealing operation between the roof and the rear header outer joint inadvertently omitted.

1. Open the taildoor.
2. Release 17 clips securing the taildoor aperture secondary seal to the body, remove seal.
3. Clean between the roof and the rear header outer joint (see illustration 1).
4. Apply a continuous bead of sealant between the roof and the rear header outer joint (inset in illustration 1).
5. Wipe off any excess sealant.
6. Fit and secure the taildoor aperture secondary seal to the body.
7. Close the taildoor.
