TECHNICAL BULLETIN

MODEL/DERIVATIVE:
Discovery Series II (LT)

Bulletin No: 0117
CDS. ref: L8861bu
Issue: 1
Date: 03.07.03

WATER INGRESS - WET HEADLINING

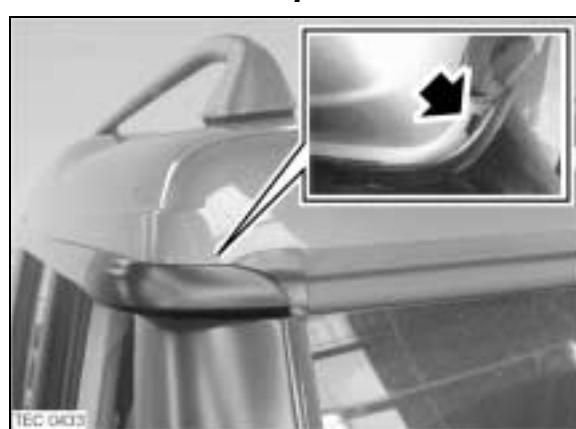
1. Carefully lift the clip securing the drip rail corner finisher to the drip rail (arrowed in illustration 1), and inspect the drip rail seam joint for a gap / void.
2. If a gap / void is present, refer to the drip rail rectification procedure.

1. Remove the windscreen side finisher. Refer to Workshop Manual, part number VDR100090 (8th edition), Exterior Fittings, Side Finisher - Windscreen, repair number 76.43.39.
2. Release and remove the drip rail corner finisher from the drip rail.
3. Clean the drip rail.
4. Fill the gap / void with sealant (see illustration 5).

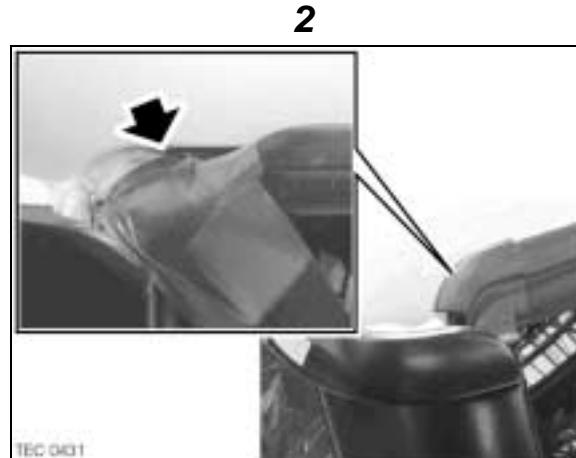
2

3. Carefully pull back the corner of the windscreen upper finisher and using tape secure it to the windscreen (see illustration 2).
4. Inspect for pin-holes / cracks around the 'A' post / roof panel, and the drip rail sealed joints (arrowed in illustration 3).
5. If pin-holes / cracks are found; refer to the 'A' post / roof panel rectification procedure.
6. If no pin-holes / cracks are found; remove tape securing the windscreen upper finisher to the windscreen and push the windscreen upper finisher back into position.
