TECHNICAL INFORMATION

LAND-ROVER

'E' Post Trim Area - Water Ingress

Discovery

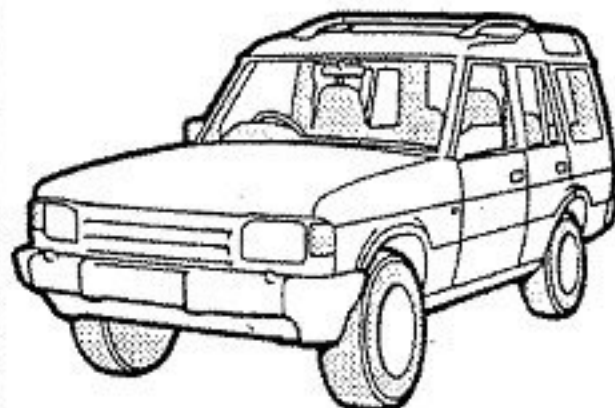
ILLUSTRATION

Investigations have shown that on some vehicles water can enter into the vehicle around the 'E' post, there can be several causes for water ingress in this area, all known water ingress paths and fixes are detailed on the flow chart attached.

Water drips from alpine light
(see illustration, arrow B)

Water evident on rear right hand floor
carpet

Water drips from cantrail inner near 'E' post

Reseal alpine light glass to rubber and rubber to
body on outside surface

Check fixed glass sealing and reseal as
necessary (see illustration arrow C)

Check for cracks around flange see 'E' on
illustration, reseal each side of flange.
The flange has been moved inside can't
rail to improve water ingress concerns from
Vins 199607 and 530346

Inspect Zinc tape for pin holes and reseal as necessary
(see illustration arrow A)

Inspect cantrail to bodyside joint for pin holes and reseal as necessary
(see illustration arrow D)

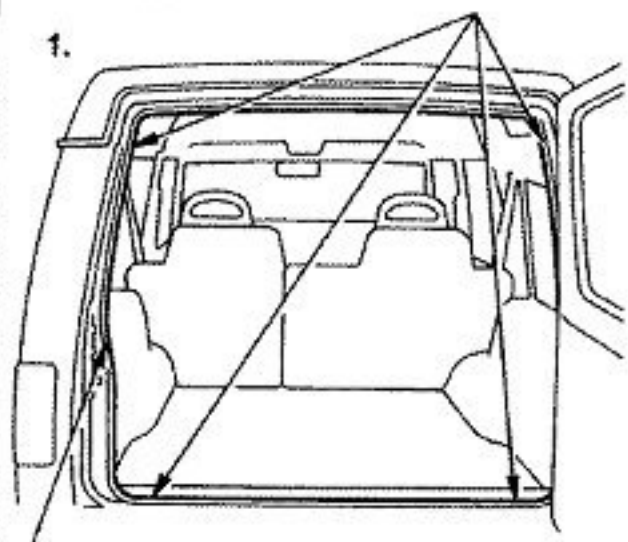
As part of ongoing quality improvements a new double bubble seal has been introduced onto the rear tail door. Early indications have identified a potential water leak from this area due to seals fitting incorrectly on a misformed seal flange. Investigations by Land Rover engineers have found that following procedure overcomes this issue on all vehicles.

1. Remove rear end door tread strip.
2. Remove rear end door seal from failed vehicle.
3. Using a craft knife, cut any excess trim tape that has been wrapped around the rear end door aperture see illustration 3.
4. Dress any flanges that appear to have panel mismatch to obtain a tight finish see illustration 1&2.
5. Smooth in Butyl around the four areas where the panel meets and form a channel to obtain a smooth finish for the foam tape see illustration 1&2.
6. Carefully apply the foam tape around the aperture as close as possible to the edge of the panel. Remove backing paper, smooth out, avoid any creases see illustration 1.

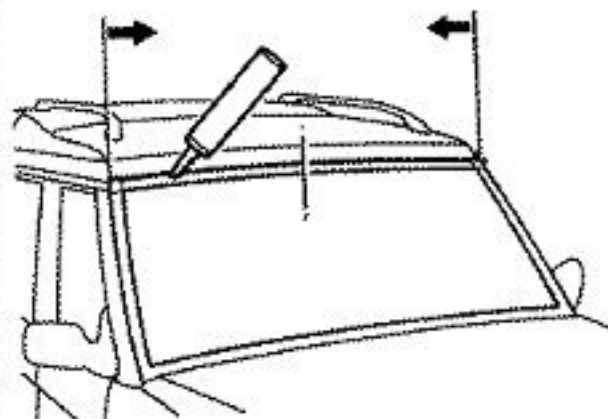
ILLUSTRATION

To overcome water ingress through the upper section of the windscreen seal a process has been developed to introduce a supplementary sealing operation behind the seal. Should a vehicle exhibit water ingress from this area follow the procedure below.

Locate sealant nozzle between top windscreen rubber and roof panel, extrude bead of sealant (continuous) from the centre of the vehicle towards the corners (see illustration opposite).

Care point: angle the sealant away from the painted panel.

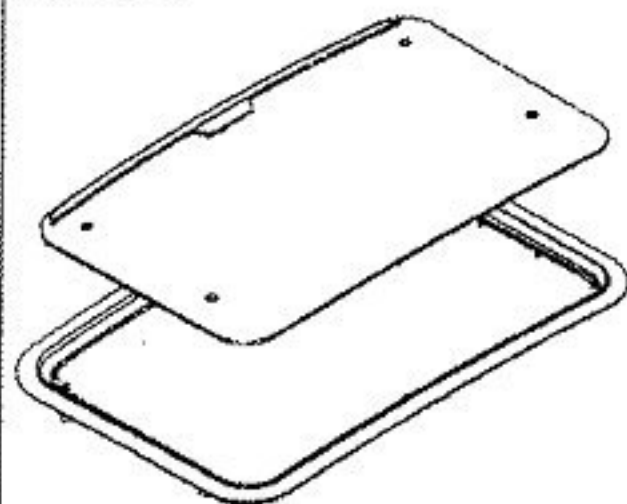
ILLUSTRATION

A small number of reports have been received that identify water ingress through both front and rear sunroofs. The reports indicate 2 areas of concern, 1) water drips from the water dam and appears to drip from the sunroof handle / motor and headlining, this may be due to the absence of the water dam gasket.

2. Water ingress between the sunroof glass and glass seal

Process for fix No 1 Gasket missing from the water dam, refer to the workshop manual section 76 sunroof Electric/Manual.

1. Remove front inner sunroof catch cover and check for water ingress.
2. Remove 2 off torque head bit fixings (size TX 20) and remove the sunroof catch body.
3. Using a torch and probe check if the water dam gasket is present (the gasket can be identified by the cross hatching on the surface, or a probe can be inserted inside the catch, if glass contact is made the gasket is missing).
4. If the gasket is missing replace the glass panel with a new assembly see parts information.
5. If the gasket is present re-fit catch, re-tighten catch fixings to 2 Nm.
6. Ensure a 5mm gap exists between the front edge of the sunroof and inside edge of the upper frame.
7. When the new sunroof assembly is fitted, check the sunroof operation and re-test for water ingress.

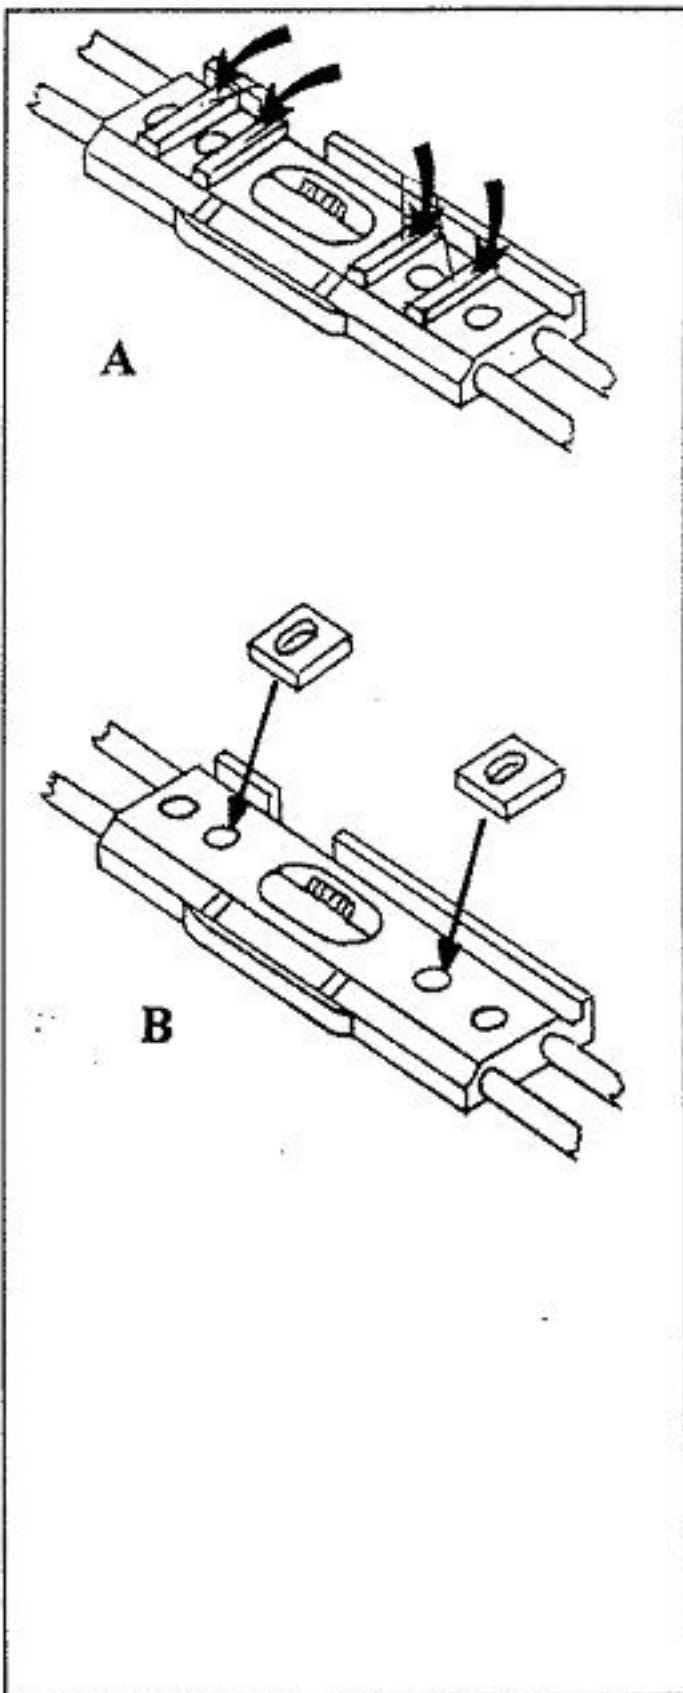
MODIFIED GUIDE TUBE (ILLUSTRATION A)

Underside view between upper frame and guide tube.

GUIDE TUBE UNMODIFIED (ILLUSTRATION B)

When fitting a modified lower tray to an unmodified guide tube x 2 spacers must be fitted to the guide tube.

Gently lift the guide tube assembly off the two locating pegs on the upper frame to gain enough clearance to insert the spacers over the two inboard holes as indicated then reseal the guide tube assembly.

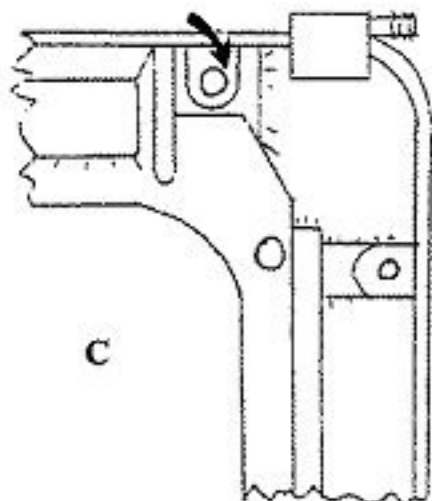
MODIFIED LOWER TRAY ILLUSTRATION 'C'

Underside view look for 'U' shaped impression around corner hole as shown opposite.

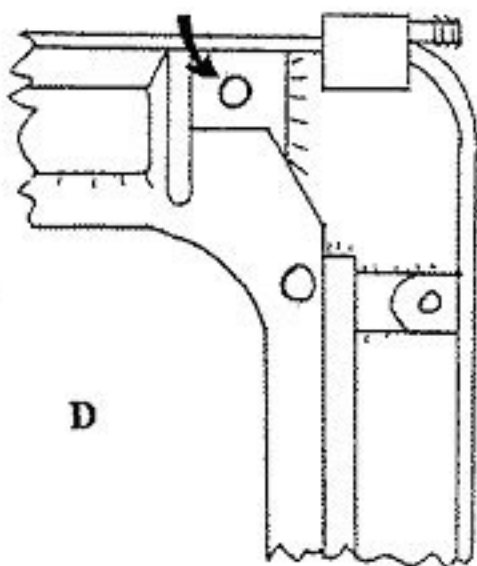
LOWER TRAY UNMODIFIED 'D'

Underside view no impression around hole as shown opposite.
