TECHNICAL INFORMATION

LAND-ROVER

'E' Post Trim Area - Water Ingress

Discovery

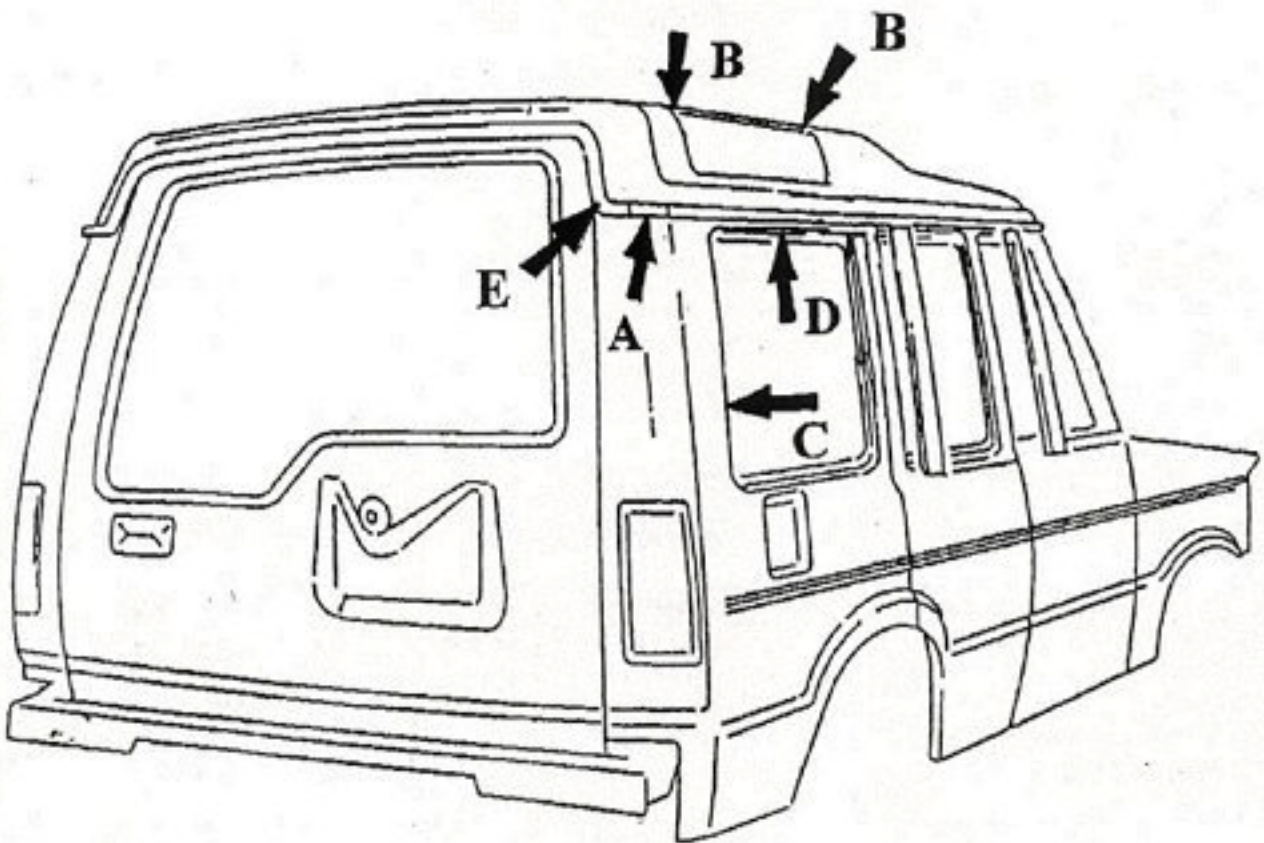
Check for cracks around flange see 'E' on
illustration, reseal each side of flange.
The flange has been moved inside can't
rail to improve water ingress concerns from
Vins 199607 and 530346
